S1147 – Hull Condition Survey Report on:

Gibbs 40 TSDY [REDACTED]

Hull Condition Survey Report on MotorYacht [REDACTED]

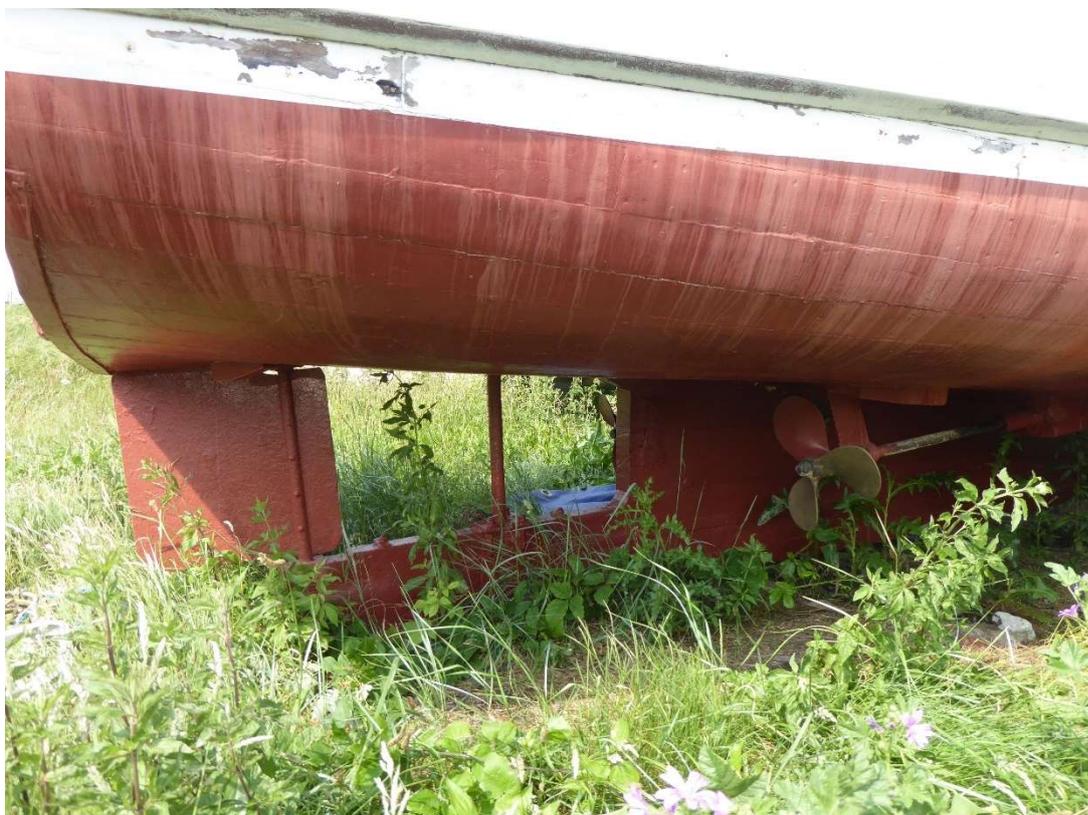
It is understood that the vessel had been laid up for an extended period in a mud berth at the river margin. It is probable that the after hull of the vessel was inadequately supported by the centre spine and that the transom has dropped by about 2" leaving a hogging in the aft hull bottom sections.

This damage is evidently after the vessel was last in commission as this hogging has resulted in the rudder becoming wedged under the transom and immoveable. In the hull bottom internally, the framing timber heels are morticed into the stern knee and these joints have opened up.

The rudder jammed under the hull bottom and the hogging in the keel cutaway

(Cat 1) Provide support for the transom with gentle upward pressure to attempt to recover some of the after hull shape. This should not be too extreme so as to avoid damage. The shape should be monitored and pressure adjusted as shape recovers.

(Cat 1) Add additional longitudinal structural members to the after hull sections. Double the cracked framing timber in way of the forward end of the transom knee. This should span at least three planks either side of the keelson.

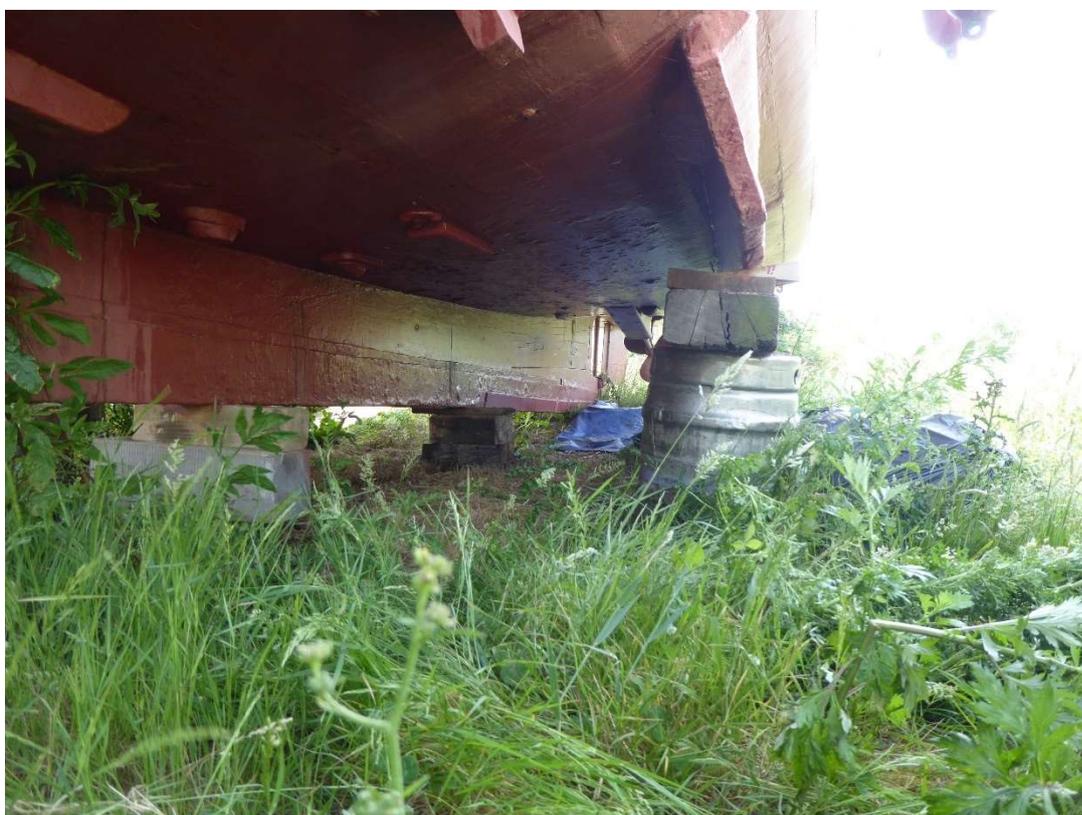
In the normal condition of the vessel afloat, this would not be a problem as the hull would be supported by water pressure over its whole surface. When laid up the hull should be supported with shores under both the bilge runners and the transom. When the vessel is laying in a mud berth the transom is completely unsupported.

General arrangement for shoring of keel and bilge runners
